# Manhole Inspection Summary

Manhole # S37I\_\_050MH

**Inspection** ☐ Is Incomplete Rating: **3) Fair**

**Location** Address: **115 market place**

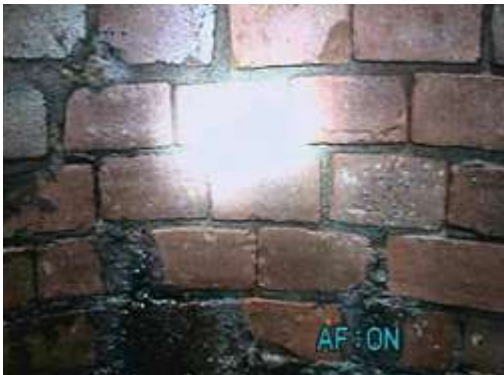
Defect 3

Infiltration: ☐ None ☐ Joint ☐ Cracks ☐ Mortar ☐ Roots ☒ **Wall**

infiltration in barrel wall

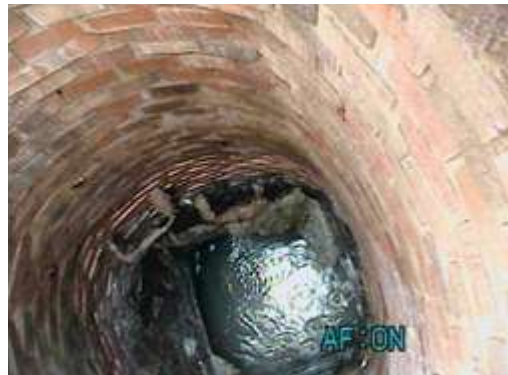
Defect 2

Count: **3** Missing: **1** ☒ **Corroded**

missing and corroded steps

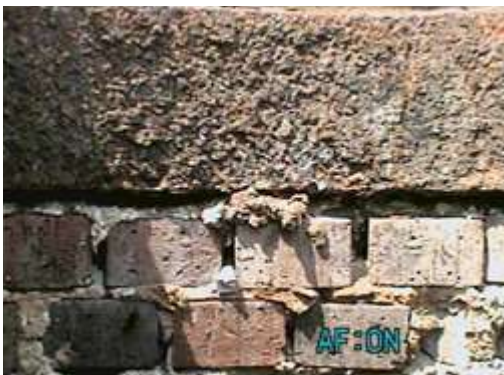
Defect 1

Condition: ☐ Sound ☐ Cracked ☐ Root Intrusion ☒ **Loose Brick** ☐ Deteriorated

loose bricks, frame adj

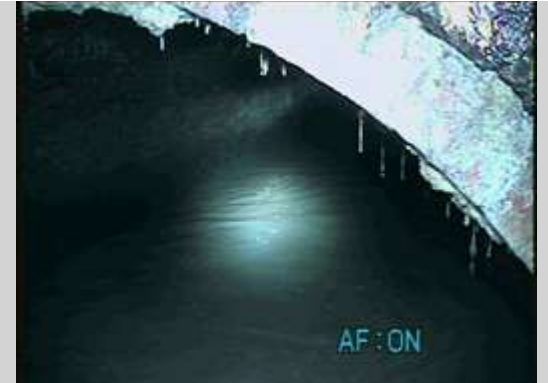
12 O'Clock Outflow

right side of 76" pipe

Invert Depth: **15.60** (ft.) Flow Characteristics: **Turbulent**

Infiltration: **None** Pipe Seal Cond: **Unknown**

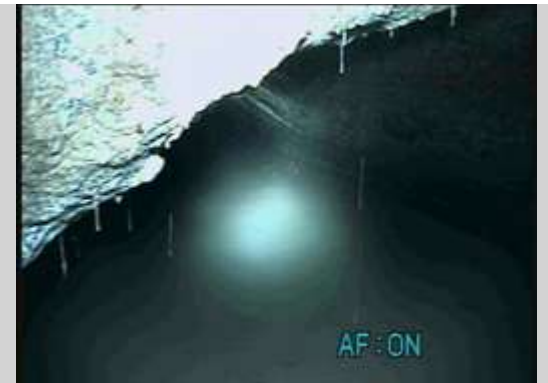
6 O'Clock Inflow

left side of 76" pipe

Invert Depth: **15.41** (ft.) Flow Characteristics: **Turbulent**

Infiltration: **None** Pipe Seal Cond: **Unknown**

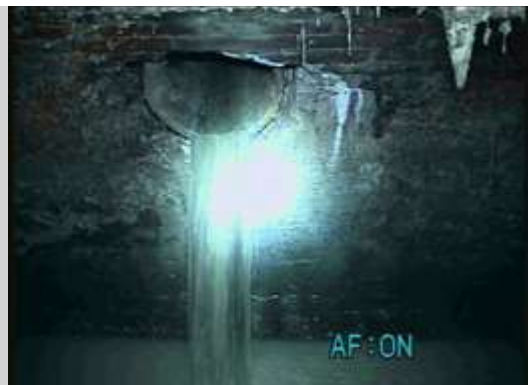
9 O'Clock Inflow

Invert Depth: **15.58** (ft.) Flow Characteristics: **Turbulent**

Infiltration: **None** Pipe Seal Cond: **Unknown**
